HARE & HUMPHREYS

CONSERVATION REPORT
ST PETERS CHURCH, PRESTON PARK, BRIGHTON, BN1 6SD
May-September 2018

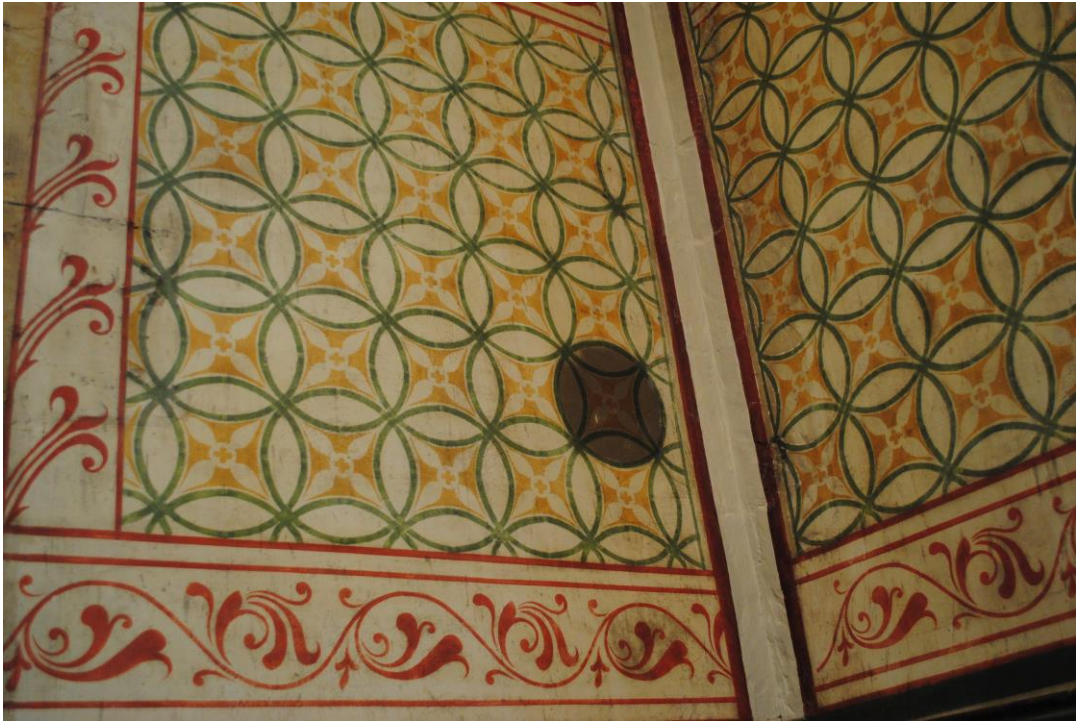
Fig. 1 Witness patch left in the North East corner of the chancel documenting the contrast in colour before and after treatment.

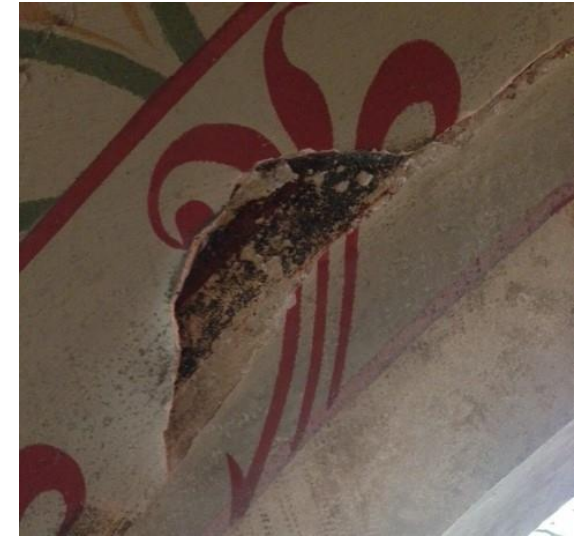
Fig. 2 Losses to the painting expose an earlier scheme of red and black appearance

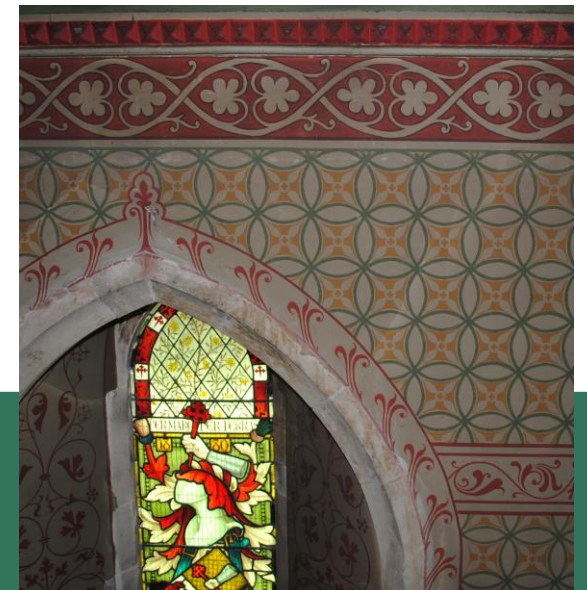
Prior to treatment, the chancel at St Peters presented a severe build up of both surface dirt, ingrained dirt and grime, flaking paint, structural damages associated with extensive damp and consequential losses to the scheme. Areas identified with most extensive damage were identified in the corners of the chancel and the lower green areas, particularly the south wall which has been most severely effected by damp.

Fig. 3 Discoloration of the scheme before treatment

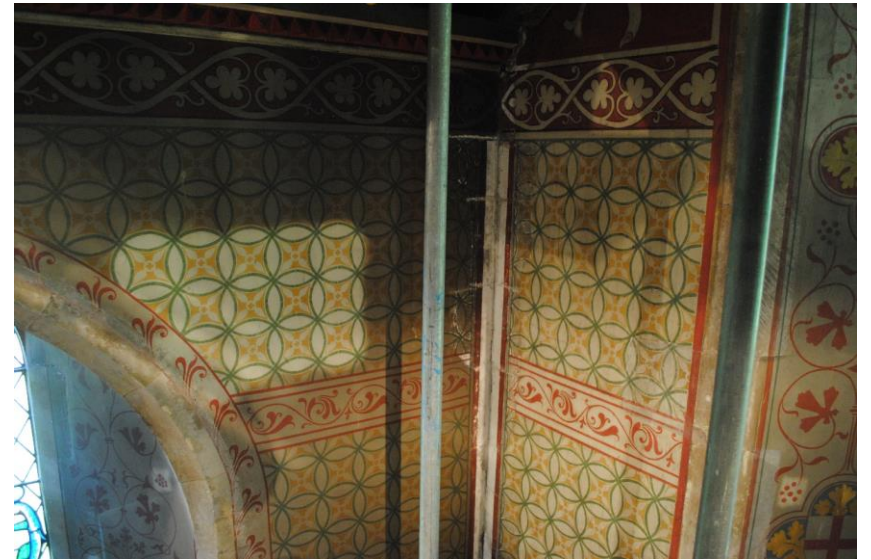
Fig. 4 During treatment of the North East corner

Despite challenges, the restoration of the chancel was successfully completed in September 2018 with the substrate stabilised, losses integrated and scheme brightened to the original Edwardian scheme, exposing the colours originally intended. Fig 4, a photograph taken during cleaning treatment exposes the contrast between the cleaned and uncleaned areas of the scheme and to document treatment, a witness patch in the form of an untreated circle of the stencil detail has been left in the North East corner (Fig. 1). However, despite the successful treatment it would be recommended monitoring of the wall paintings is continued (refer to Monitoring Recommendations).

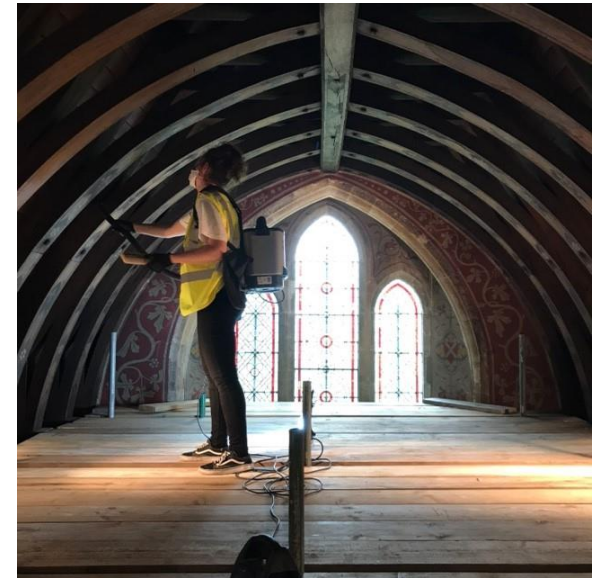
Fig. 7 Surface cleaning the rafters using vacuum

The first stage of treatment was to remove the extensive accumulation of loose surface dirt, dust and debris from the rafters and walls using soft bristle brushes and vacuum packs (Fig. 7). The gentle surface clean exposed the area of paint which were loosely adhered and therefore at risk of disruption during treatment, these areas were documented and addressed with primary importance. Areas of vulnerability can be identified in Fig. 8.

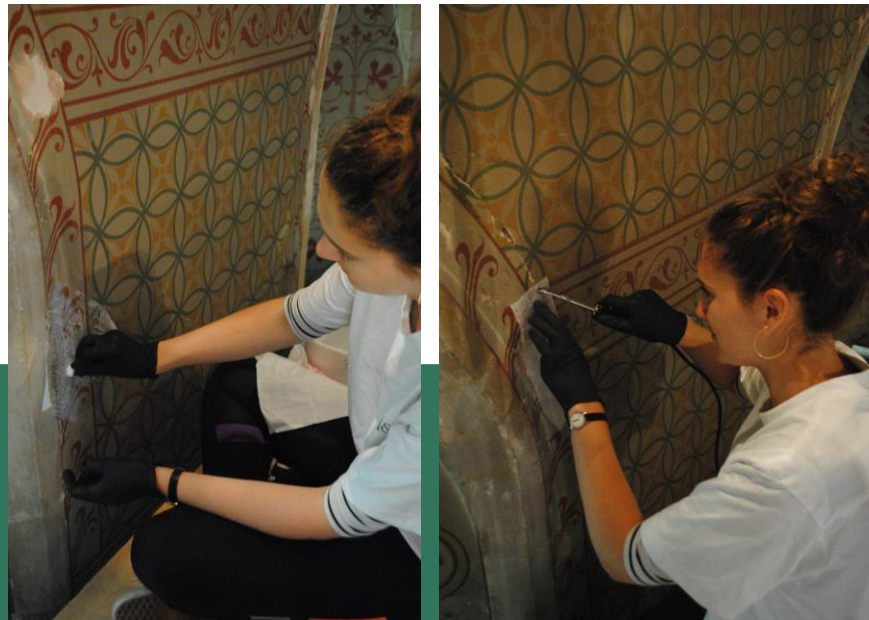
Fig. 9 Consolidation. Application of adhesive through pre-wetted tissue membrane (left). Re- plasticising the raised paint using the heated spatula over protective layer of silicone release paper (right)

The areas identified to be at high risk of flaking were consolidated using the adhesive Plextol B500, applied with syringes where access could be gained behind the flakes, or with artists' brushes depending on the individual areas of concern. A poultice application using wetted tissue was used to secure the paint flakes in position prior to adhesive application to ensure minimal losses to the original scheme. Ideally, adhesive would have been applied following cleaning treatment however the mechanical action of cleaning would have caused losses to the scheme and therefore consolidation was prioritised in the vulnerable areas.

In addition to the application of adhesive, areas of raised paint were secured using a heated spatula to re-plasticise the paint lowering vulnerable lifted paint into level plane with the scheme. Further adhesive was applied where necessary and treatment proved successful in securing the vulnerable paint layer with minimal losses to the scheme.

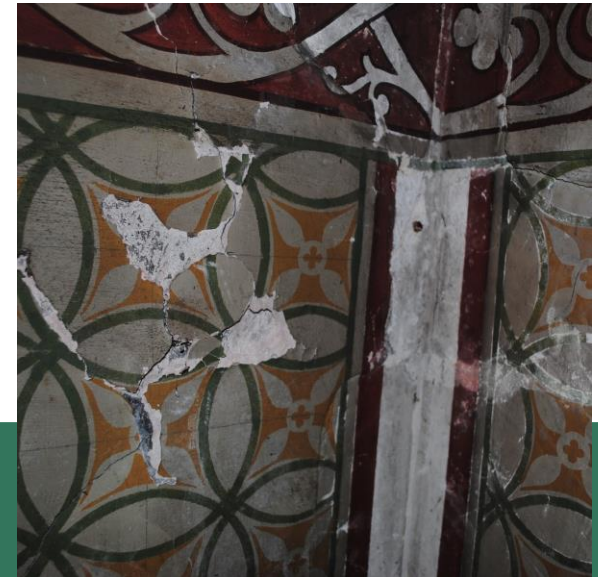
Fig. 8 Areas of loosely adhered paint and plaster in the South West corner

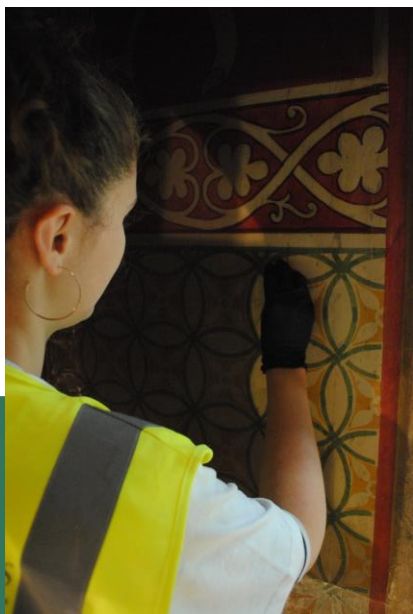
Fig. 10 During cleaning treatment

The green stencilled areas proved the most challenging aspect of the clean due to poor previous restoration attempts which had resulted in an uneven surface as well as an unsympathetic application of a dark green overpaint, presumably colour matched to the darkened green caused by layers of dirt as opposed to the original colour. With cleaning treatment, the darkened overpaint became more visible in contrast to the lighter original scheme underneath. Removal of the overpaint required the mechanical action of the scalpel which proved a pain-staking process.

The substantial accumulation of dirt, soot, pollution and grime over the 20th Century has dulled the bright Edwardian scheme which decorates the chancel. Following extensive testing of a range of cleaning materials and concentrations, 5% Ammonium carbonate in de-ionised water was selected for treatment. Prior to treatment, all colours included in the scheme were tested to ensure the paint layer would remain stable throughout treatment. Testing exposed that all paints were stable however the reds were more vulnerable and addition care and monitoring was taken in these area. Cotton swabs were used to deliver the solution and with mechanical cleaning action, agitated and then remove the dirt layer.

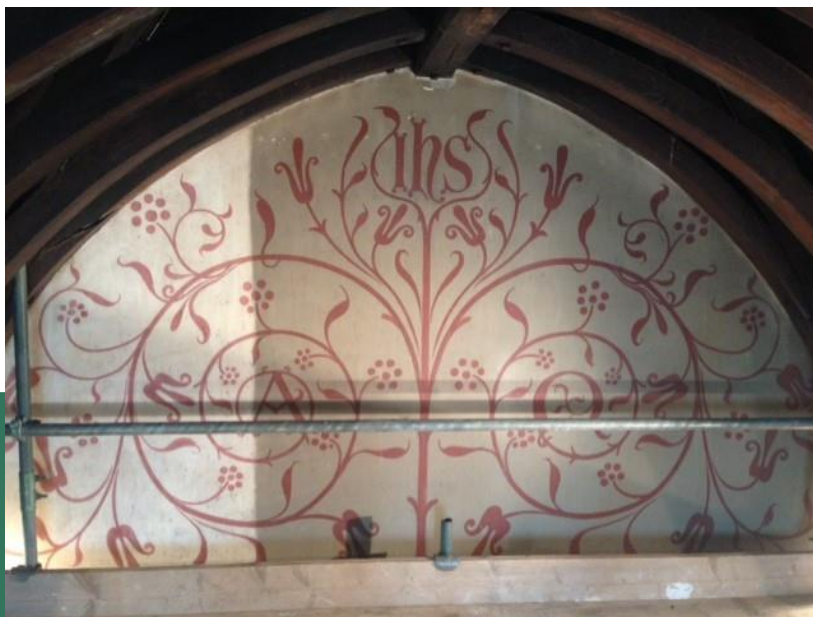
Fig. 11 During cleaning treatment of the tree to the west chancel wall

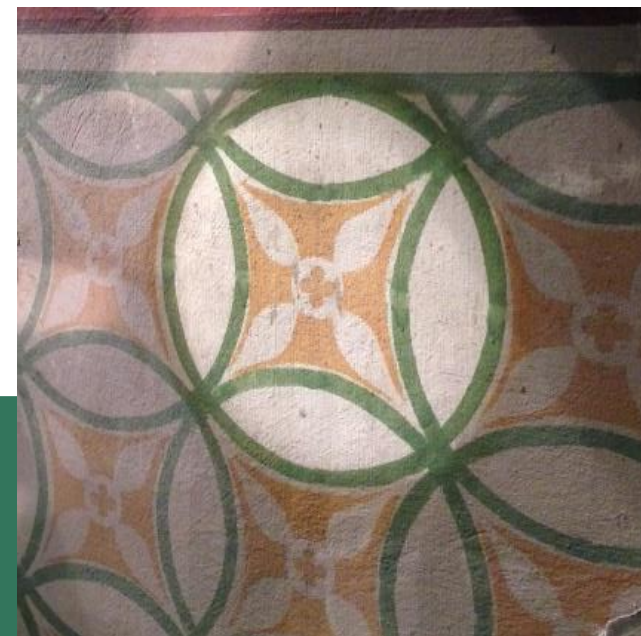
Fig. 13 The cleaned circle within the stencil exposes the contrast in colour against the surrounding dirt

Swabs were collected for safe disposal and the areas were cleaned with deionised water to neutralise remove any residues. During treatment, areas were carefully monitored to ensure no damage was being caused to the scheme. Treatment successfully removed the extensive layers of dirt and grime to expose a remarkable contrast to the scheme below (Fig. 13)

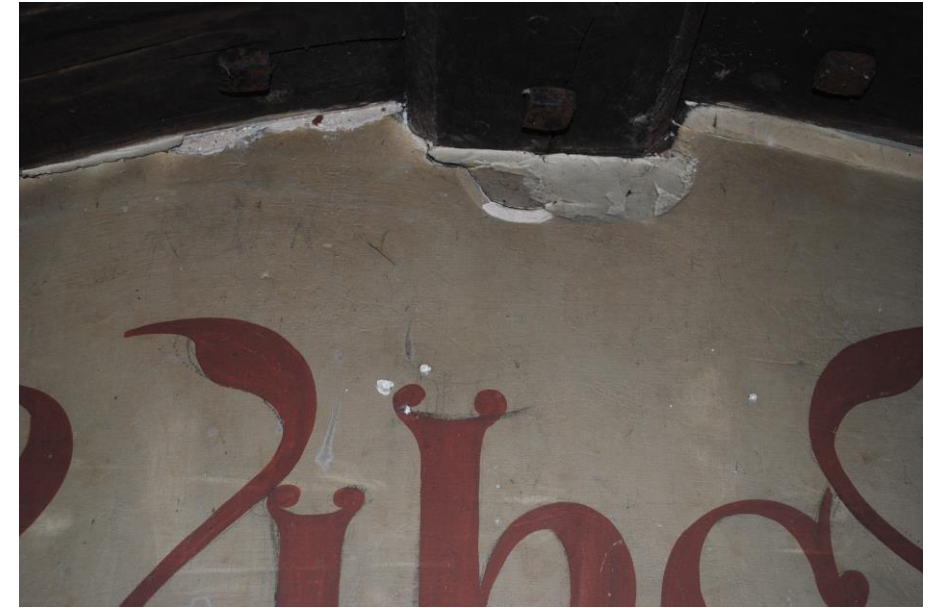
Fig. 14 West Chancel wall. Before Treatment

In addition to the challenges encountered in the lower green areas, an unforeseen outcome of treatment was revealed in the upper sections of the scheme. The removal of the layers of dirt and grime revealed an extensive series of dark drips/splashes on the wall paintings, most concentrated to upper layers, particularly the West Wall of the chancel and the windows above the altar. These particular darkened drip marks were unresponsive to ammonium carbonate, and due to their location, it was speculated that these drips could have been the result of varnishing/waxing of the rafters with the drips then trapping dirt on the surface, probably unnoticeable at the time.

To address the drips, acetone was applied with cotton swabs and swab sticks which reduced the impact to a minimal degree however following treatment traces were still present although to a much less dramatic effect than initially uncovered. The wall opposite the altar with the tree mural was most disrupted, probably due to the large surface area and the contrast with the darker drips, a further 2 days was spent to reduce the drips in this area. Where considered appropriate and necessary to reduce the visual impact of the drips, gouache was applied to encourage integration.

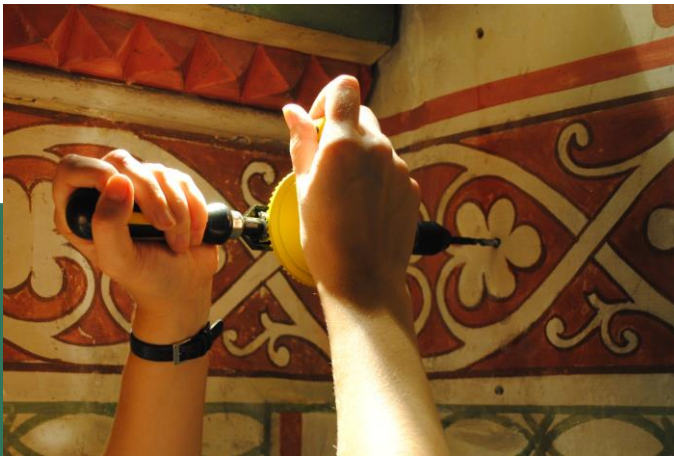
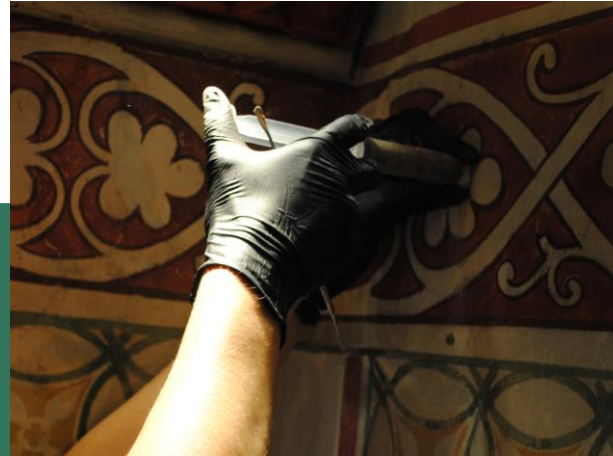
Fig. 18 Structural treatment filling the hollow pockets to the South West corner of the chancel . Drilling holes (left) filled injected with trass (right)

However, more invasive structural treatment was required for areas with losses to the plaster and in areas which had bulged resulting in hollow passages behind the exterior plaster layers. Initial stages of treatment included the removal of loose plaster by mechanical raking out. A mixture of Trass (natural volcanic ash containing silica), hydrated lime and water was then applied into the structure using a syringe. The mixture forms a fine paste suitable for losses in the wall and also to fill any hollow pockets which would be vulnerable if left untreated. To address the hollow pockets, a hand drill was used to create minor holes in the wall (Fig. 18), into which the Trass Mixture could be applied (Fig. 18). Prior to application a syringe of de-ionised water was injected into the pockets to ensure adhesion and also to gain greater understanding of the pocket topography. Treatment applying the Trass was carried out in stages, mechanically encouraging the fill into the crevice's of the losses to ensure an even distribution of filler. Extreme care and caution must be observed during treatment to avoid excess filling which risks the stability of the painting by 'exploding' the plaster thus cracking the original scheme.

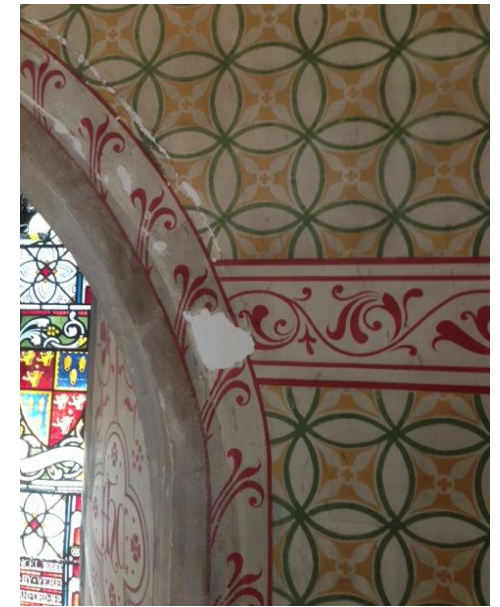
Fig. 16 Losses after filling with Flugger ®

The filling treatment carried out included both minor fills to address and integrate paint losses as well as more invasive structural treatments. For the areas requiring minor fills following stabilisation treatments (consolidation and re-plasticising of the paint layer), Flugger® filler was applied to the losses in a fine layer using a spatula (Fig. 16). To isolate the filler, a layer of Plextol B500 was applied prior and post application. In addition, where appropriate, cracks were also filled with Flugger® however depending on the location of size of the cracks, some remained untreated based on the understanding that further cracks would be created in those areas in the future (i.e above the arch of the stained glass window at the East of the chancel).

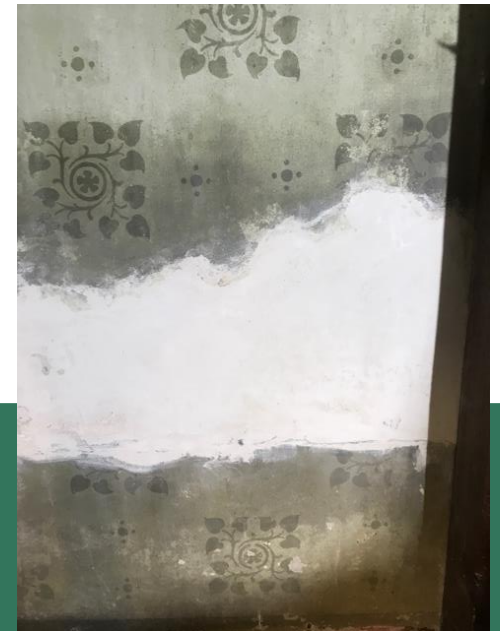
Fig. 17 Hydraulic lime/sand and de-ionised water before image reintegrating ®

For larger areas which did not require injecting, a mixture of fine sand, hydraulic lime and deionised water was applied using filling blades (Fig. 17). The fills were sanded down and levelled into plane with the painting to ensure an even surface prior to image reintegration. Filling treatment proved succesful, using a selection of different materials and methods to respond to the unique demands of the chancel.

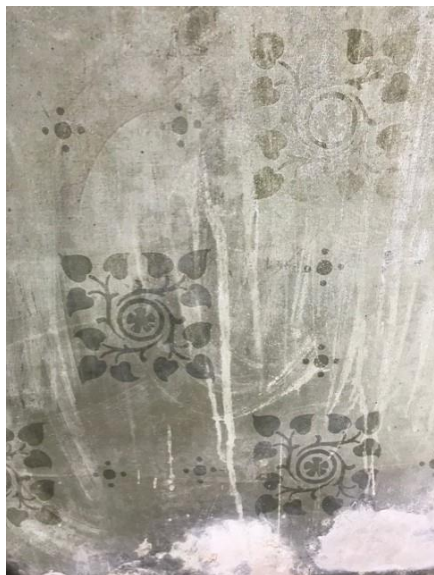
Fig. 19 Uneven surface prior to treatment Fig. 20 Application of Gouache paint to integrate losses

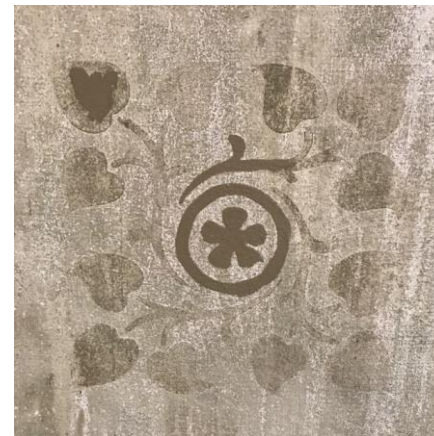
Fig. 21 Before treatment (top)
After stencilling (below) reintegrating
the original scheme

In the filled areas of the lower green sections a series of washes were applied as a base coat. In addition, the red border at the base of the scheme was reinstated as was the darker green stencilled detail, areas of which had been lost as a result of the extensive damp caused to the chancel. A tracing had been taken from the original scheme with a stencil made to ensure the original methods of application were followed during treatment. Additional areas were retouched using a brush (Fig. 20).

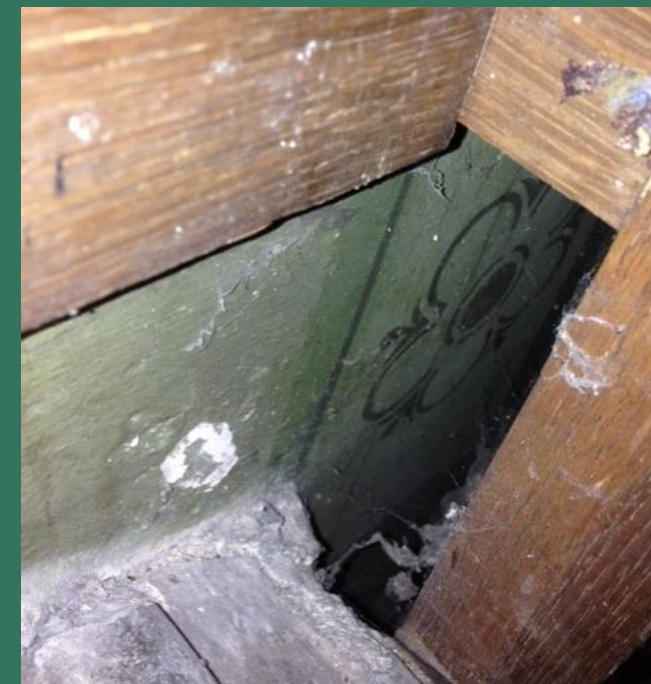
Interestingly, upon closer inspection a previous stencilling scheme can be identified in St Peters; both as a faint print in the cleaned green background and also behind the altar (Fig. 22). Although similar to the stencilling in situ today, the previous stencil presents a more rounded scheme as opposed to the square detail identified in Fig. 21.

It appears that the scheme identified in Fig 22 was the original chancel stencilling of 1878 with the scheme today being painted in 1906 following the fire

Fig. 22 Suggested original stencilling scheme from 1878
