HARE & HUMPHREYS

CONSERVATION REPORT
ST PETERS CHURCH, PRESTON PARK, BRIGHTON, BN1 6SD
May-September 2018

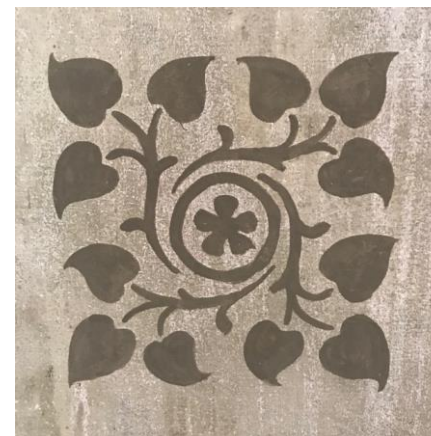
Fig. 22 Suggested original stencilling scheme from 1878

Interestingly, upon closer inspection a previous stencilling scheme can be identified in St Peters; both as a faint print in the cleaned green background and also behind the altar (Fig. 22). Although similar to the stencilling in situ today, the previous stencil presents a more rounded scheme as opposed to the square detail identified in Fig. 21.

It appears that the scheme identified in Fig 22 was the original chancel stencilling of 1878 with the scheme today being painted in 1906 following the fire
